Test Report

Prepared For:
Interface Protection Group

Test Performed:
House Blanket Retardant Test

Report No: GVLT-092018-1

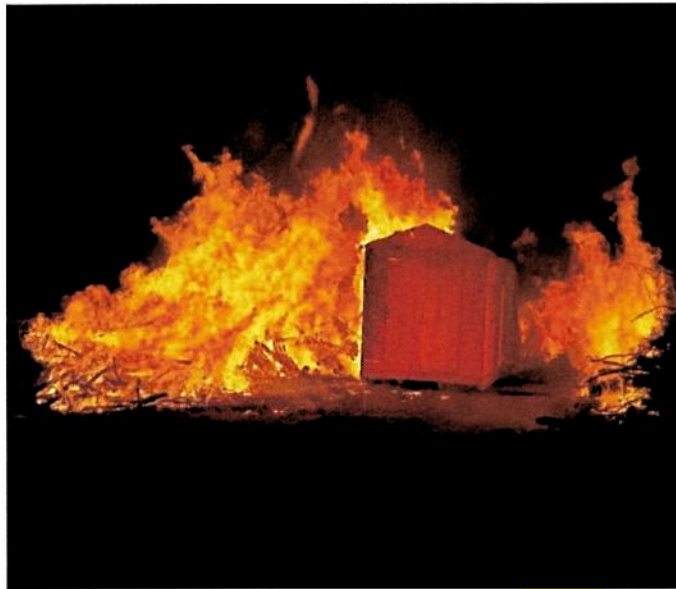
Initial Catch of Control – Standard Image

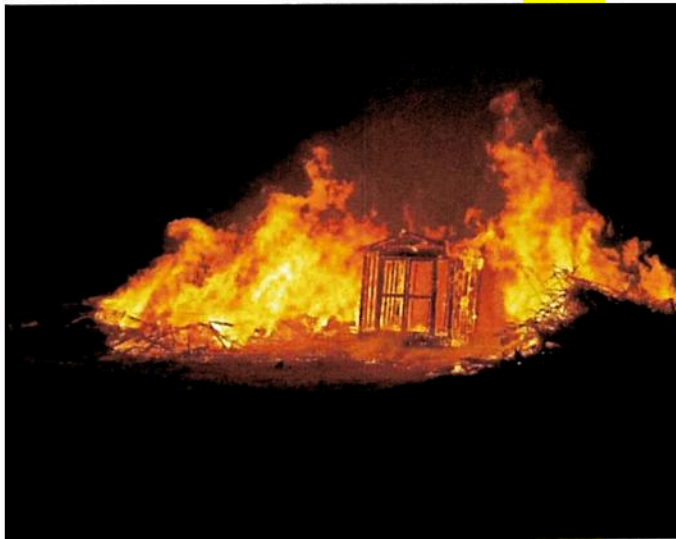
Fully Involved Control – Standard Image

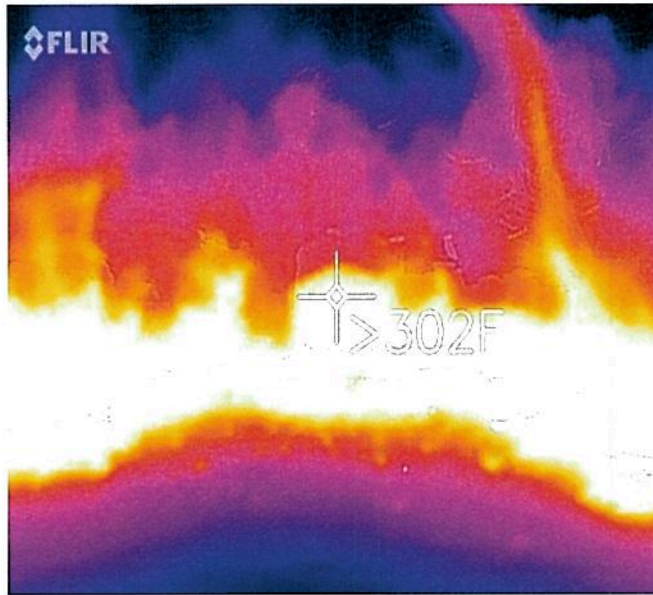
Fully Involved – Flir Image

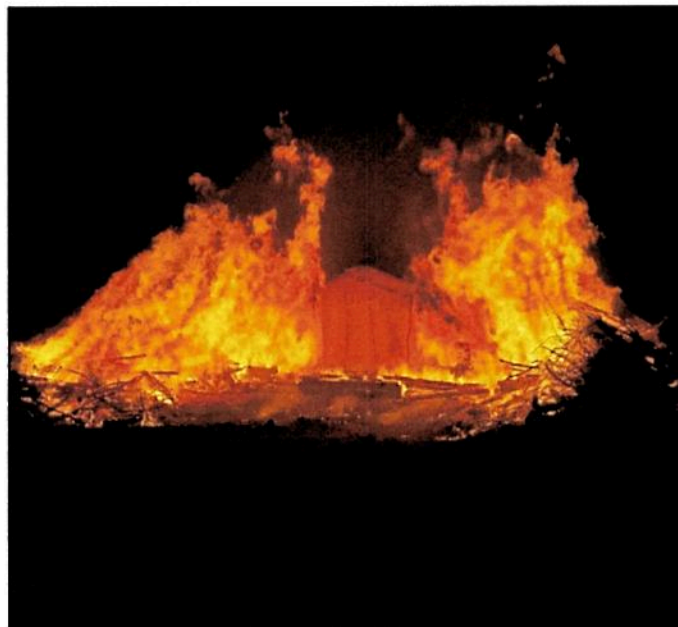
Controlled Destruction – Standard Image

The burn started at 8:00 pm. Control Building had first Ignition around 8:09pm and was completely destroyed at approximately 8:20pm. The burn temps started decreasing around 8:27pm and was settling around 10:00 pm with the test structure still intact and no burn on the thermal wrap. At re-entry the building appeared unharmed and there was no lingering smoke smell. The thermocouples were unharmed and the data acquisition systems were in working order.

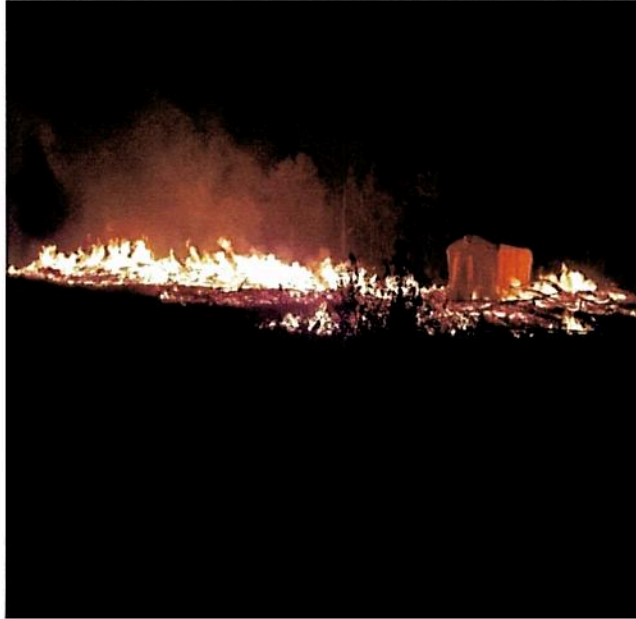
Post Test – Fire Receded – Standard Image
